Original Article

Comparative Evaluation of Sealing Ability of white MTA, Biodentine, Calcium Phosphate Cement, and Glass Ionomer Cement as Furcation Repair Materials: An Ex Vivo Study

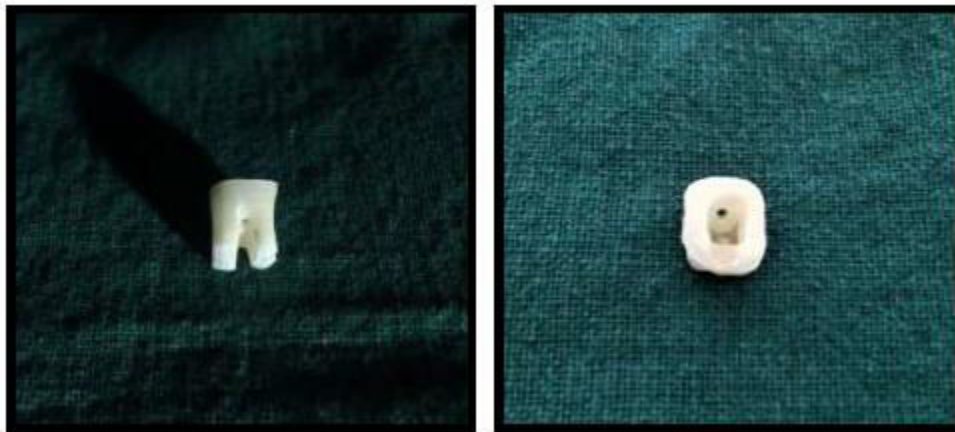
Figure 1: Sample preparation

Molars were decoronated 3 mm above the cemento-enamel junction and roots were amputated 3 mm below the furcation. A standardized endodontic access opening was prepared in all 45 samples. Sticky wax was placed over the orifice of each canal. It was then coated with two layers of nail varnish.

To ensure each perforation was centered between the roots, a black marker pen was used to mark the location of the defect. A defect 1 mm in diameter was made from the external surface of the tooth with a number 2 round carbide bur mounted on a high-speed handpiece with air water coolant. The chamber and perforation were flushed with water and dried. The teeth were kept in an incubator at 37°C for 24 h for simulating clinical conditions.

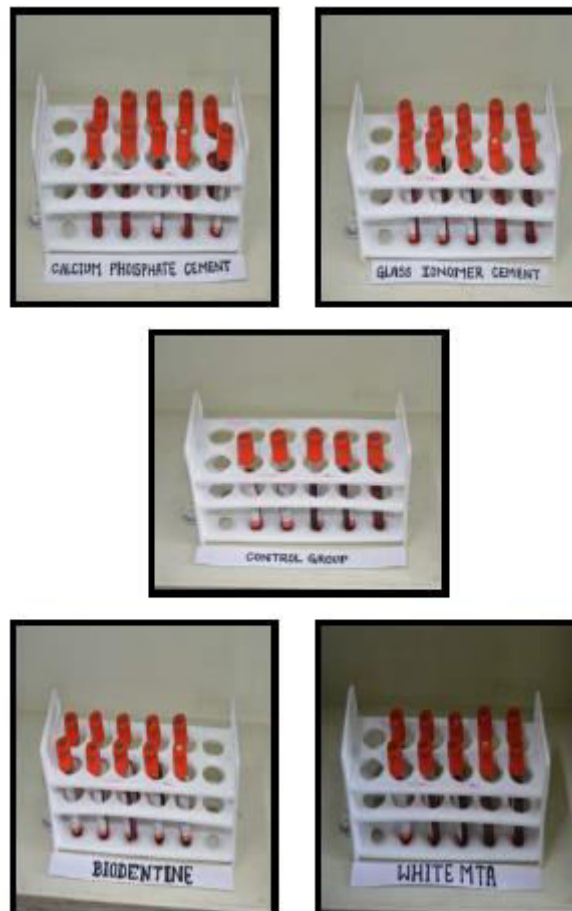
Figure 2: Samples in test tube before centrifugation

After removal of the dye, teeth were rinsed under tap water for 30 min and varnish removed with a polishing disc. Each tooth was stored in a vial containing 5 ml of concentration nitric acid (69 weight %) for 3 days.

The solutions thus obtained were centrifuged at 3500 rpm for 5 min.
